World Housing Encyclopedia

# HOUSING REPORT Unburnt brick wall building with pitched roof (nyumba ya zidina)

Report #	46
Report Date	05-06-2002
Country	MALAWI
Housing Type	Adobe / Earthen House
Housing Sub-Type	Adobe / Earthen House : Adobe block walls
Author(s)	Mauro Sassu, Ignasio Ngoma
Reviewer(s)	Manuel A. Lopez M.

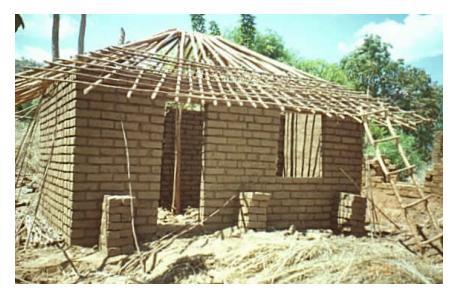
Figure 2: Key load-bearing elements

The vertical load-resisting system is timber frame load-bearing wall system. The roof loads are supported on the timber members which are supported on walls. Generally gable walls are used both internally as room partitions and at the extreme ends of the building.

The lateral load-resisting system is timber frame load-bearing wall system. The wall takes the load from the roof and wall elements. The walls are placed on a raised platform as a way of keeping above ground/surface water levels during the rainy season. This platform may be considered as a foundation because it projects outside the wall thickness and is generally constructed of stone. However, the connection between the wall and the raised platform is not structural, so there is no transfer of lateral forces at this point. The connection between the roof and the wall does not provide lateral transfer of forces.

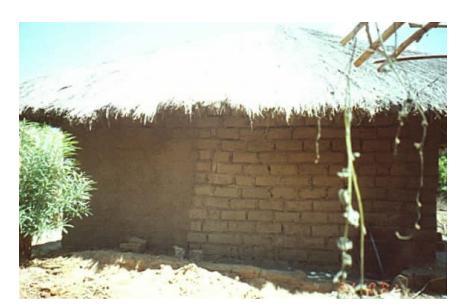
Figure 1: Typical building

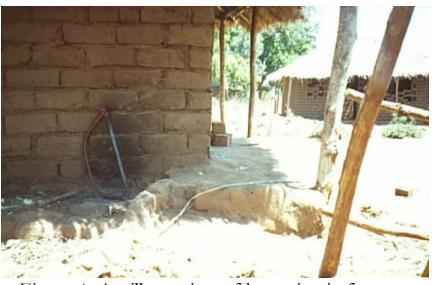
Figure 4: An illustration of key seismic features and/or deficiencies

Structural Element	Seismic Deficiency	Earthquake Resilient Features	Earthquake Damage Patterns
Wall	Poor lateral resistance, weak timber lintels.	Gable construction.	
Frame (columns, beams)			
Roof and floors	Roofing timber embedded in wall.	Light roof system.

The construction practice is not based on engineering expertise. The tying of the wall girder to the roofing structure

contributes somehow to the seismic resistance.
