World Housing Encyclopedia

HOUSING REPORT Mud wall construction in Spiti Valley (Himachal Pradesh)

Report #	171
Report Date	05-08-2012
Country	INDIA
Housing Type	Adobe / Earthen House
Housing Sub-Type	Adobe / Earthen House: Rammed earth/Pise construction
Authors	Ankita Sood, Aditya Rahul, Yogendra Singh, Dominik H. Lang
Reviewer	Qaisar Ali

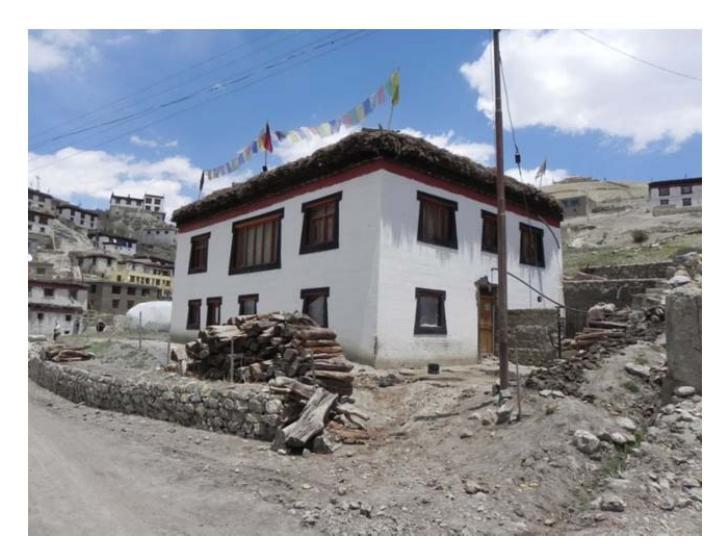
Figure 1. Typical Spitian mud house of 2 storeys.

Buildings of this construction type can be found in the Spiti river valley of the districts Lahaul and Spiti, in the state of Himachal Pradesh (Figure 1, Figure 2). As a specific term has not yet been coined for these houses, it was decided to name this construction type 'Spitian architecture'. The addressed region is a desert area where timber is scarce and mud is the main locally available construction material. The addressed buildings are therefore made of rammed earthen walls and timber is solely used for floors and roofs as well as for door and window frames. Natural stones are also scarce and are thus only used for foundations. This type of housing construction is commonly found in both rural and sub-urban areas. This construction type has been in practice for more than 200 years.

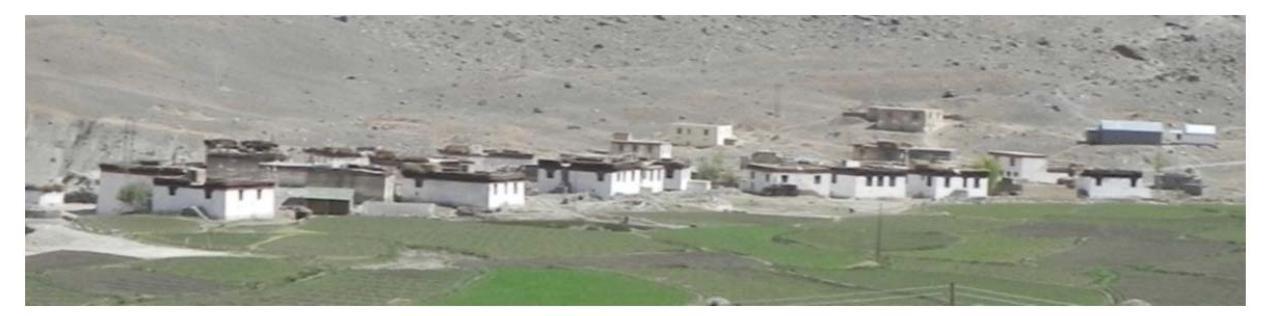
Figure 4. Houses located on flat topography in the village Kii.

These buildings are typically found on both sloped and hilly terrain. They do not share common walls with adjacent buildings. Houses in the valley are built on flat lands while those on slopes and ridges are located on flat plateaus that are artificially cut into the topographical feature. In the Spiti river valley, the village Lossar is characterized by an entirely flat topography (**Figure 4**) whereas the village Kibber is located on slopes (**Figure 5** and **Figure 6**). When separated from adjacent buildings, the typical distance from a neighboring building is a minimum of 0.3 meters.

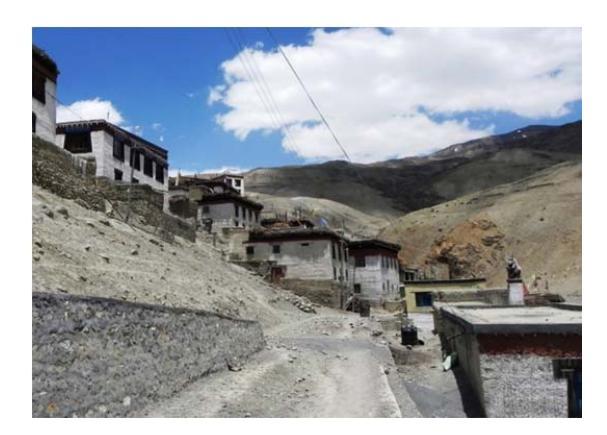
Figure 5. Houses located on slopes.

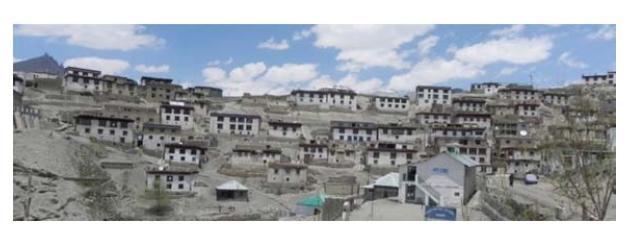
Figure 6. Houses built on hilly slopes in the village Kibber.

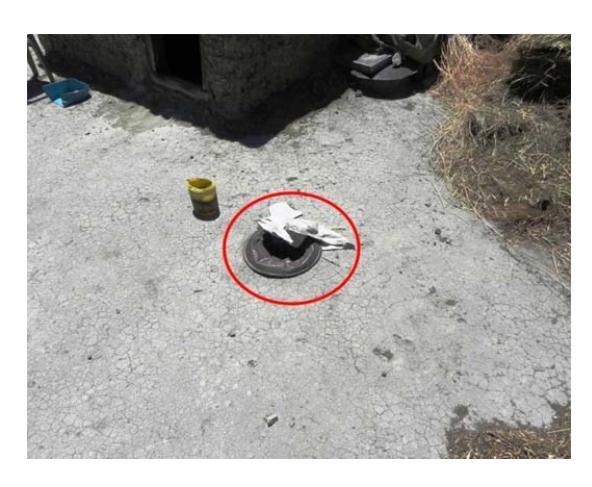
Figure 7. Sky-light as seen from terrace.

The houses are generally rectangular in plan without any verandah. A typical house is of two to three storeys with the lower storey used for cattle and the upper storey(s) for the family. Openings are generally of small size. In some cases, skylights are provided in the roof in order to provide natural light to the interior corridors and staircases (**Figure 7** and **Figure 8**).

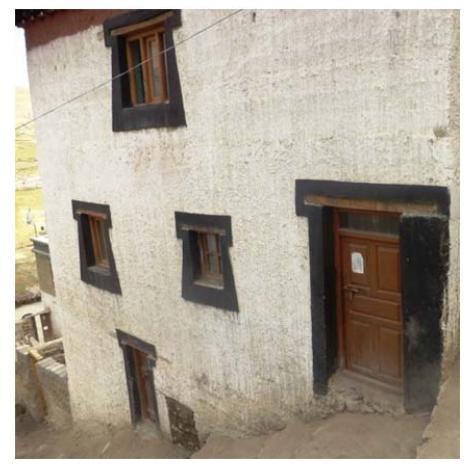
Figure 9. Doors at different levels.

The main function of this building typology is a single-family house. In a typical building of this type, there are no elevators and no fire-protected exit staircases. The typical building has generally one door other than the main entrance door which can be considered as an escape route at the buildings rear. On contoured sites, these doors may be located at different levels (**Figure 9**).

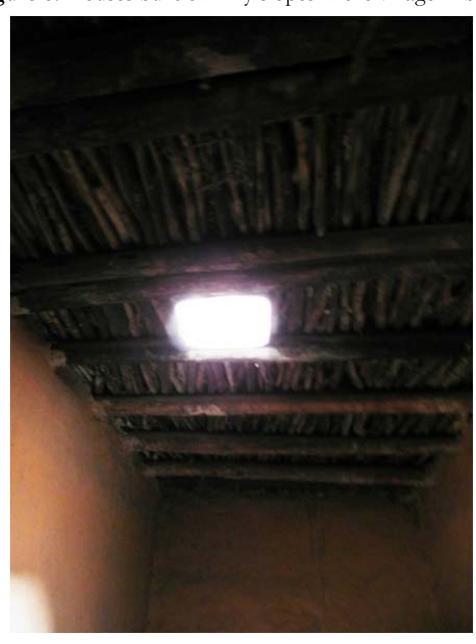
Figure 8. Light pouring in through sky-light above.

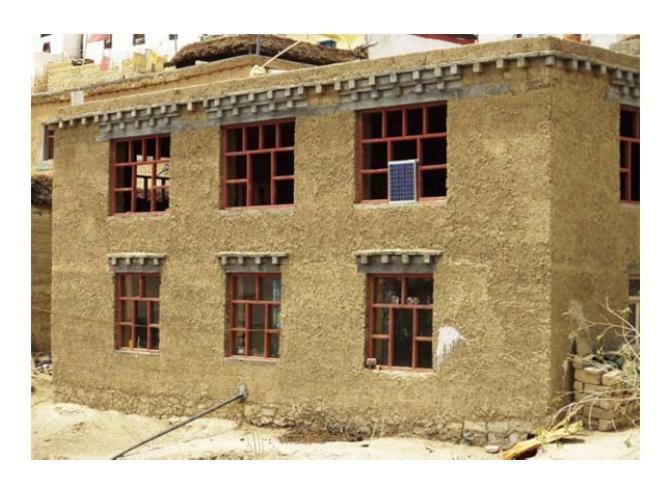
Figure 10. Precast RC lintels in a new construction.

It is assumed that buildings of Spitian architecture were designed and constructed under the influence of one particular architectural school that prioritized human comfort in the harsh weather conditions while being constricted to using locally available materials. In recent times, various experiments of construction using conventional building materials (bricks) have failed as these materials do not provide the same advantages with respect to insulation (both during winter and during summer) as mud. However, more contemporary materials have found their way into many Spitian houses, e.g. pre-cast RC lintels (**Figure 10**) which replace wooden lintels. The small open-to-sky-and-sun bath spaces (**Figure 11**) were recently replaced by enclosed winter gardens with large glass windows. A new variant can also be found in some places where single RC columns and beams are arranged (**Figure 12**).

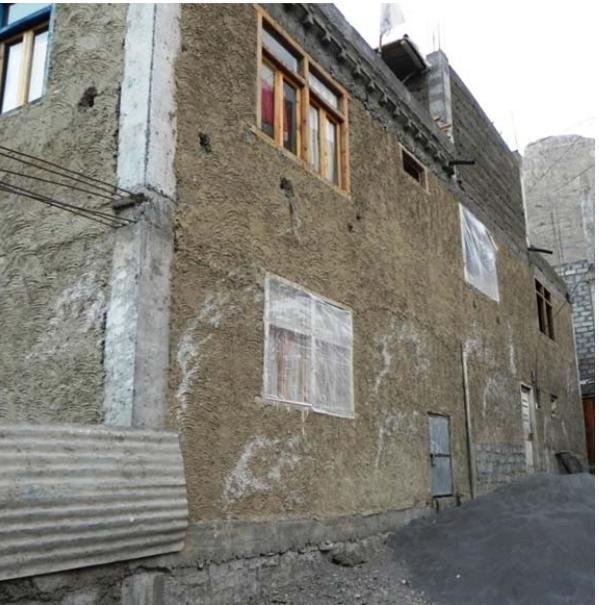
Figure 12. RC framed structure with mud walls infill and mud roof.

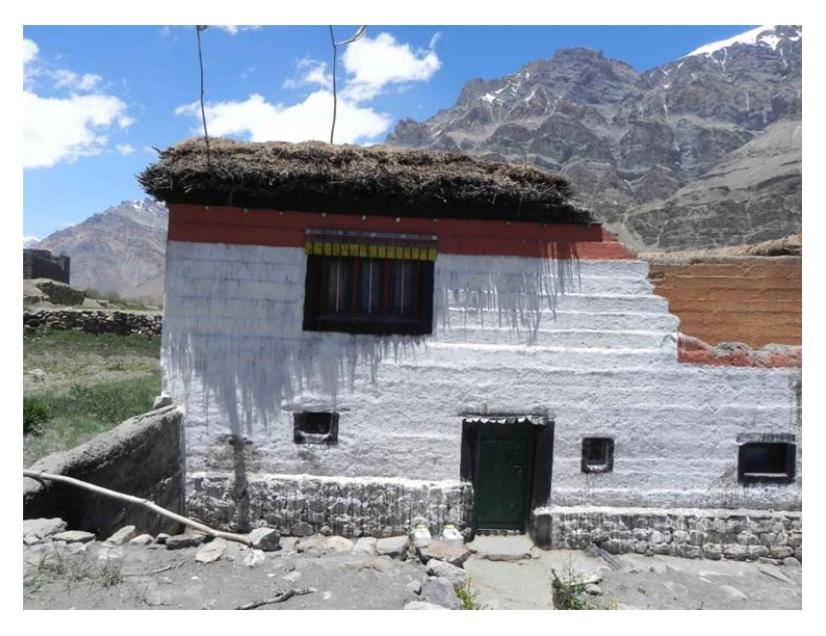
Figure 13. Lower portion of the wall made up of field stones. The front door is arranged at ground floor level without any plinth.

Locally available stone is used for foundation. A trench is dug about 300 mm in depth and 500 mm in width. Courses of stones with mud mortar are then laid in the trench up to the ground level. The same courses are then taken up to 600 to 900 mm above the ground in order to form the lower portion of the walls. Through this procedure the walls are protected from direct rain water splashes and snow. Generally, there is no plinth in these houses (**Figure 13**).

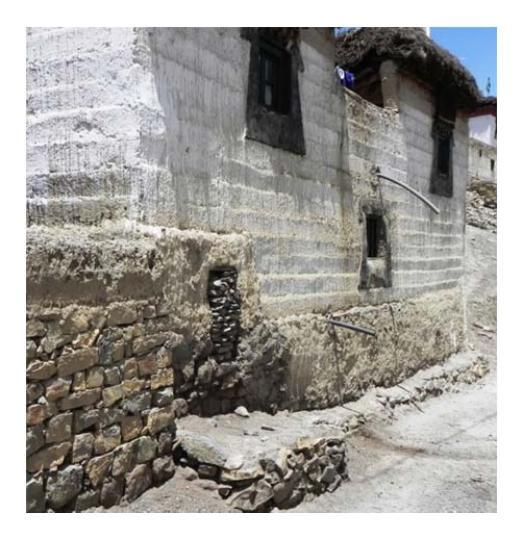
Figure 15. Over-ground septic tank's opening can be seen at ground floor level.

The toilets are a dry type and are always located on the first floor while the septic tank is located at ground level. The septic tank has a small opening in the outside for periodic cleaning (Figure 15). The opening is packed again and again with dry stones (Figure 16).

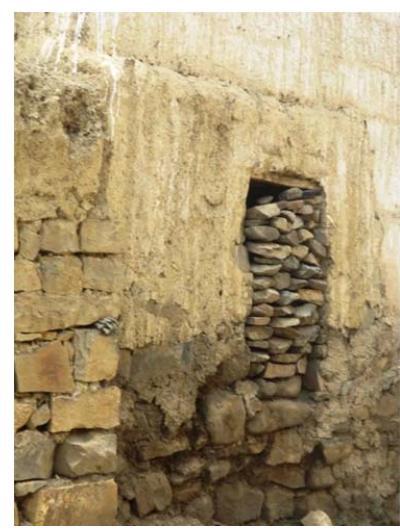
Figure 16. Septic tank's opening closed with dry stone packing.

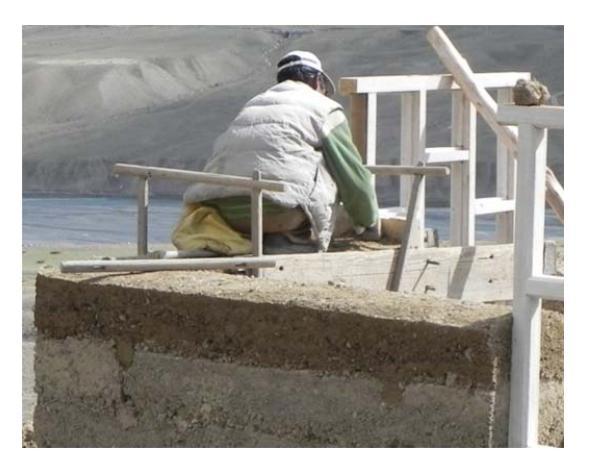
Figure 17. Wooden formwork to lay courses of mud.

Wall System: Houses of Spitian architecture have a load-bearing wall system. The 300 - 500 mm thick mud walls take up the entire load. Construction materials: The foundations and walls up to 600 to 900 mm height above the ground level are made of local available field stones. Above this base, the walls are entirely constructed of rammed earth. Construction methodology of walls: Step 1 - A wooden formwork is assembled and kept at place over the stone courses of the wall. This formwork has two wooden planks laid parallel to each other at a distance of either 300 or 500 mm and is secured at place by wooden screws and members (Figure 17). The height of the planks is generally 300 mm. Step 2 - In order to lay the first course of the mud wall, the formwork is filled with mud and rammed properly with a mallet. Once the mud sets at place, the formwork is slid further in order to make the other portions of the wall. The same procedure is repeated until the whole course of all four walls is finished. Thus a course of about 300 mm height has been prepared. Through the same procedure courses are laid one over the other in order to construct the entire wall. During the summer, it is possible to do two courses per day. In winter, only one course is laid per day and then allowed to dry/harden overnight. The horizontal borderline between two individual courses can be clearly seen on the walls. Lintel beams are placed at appropriate height during the wall construction. Step 3 - Once the walls are made and dried properly, windows of appropriate and desired size can be cut into them (Figure 18). In case of scarcity of mud, window frames are arranged in place while laying the courses (Figure 19). Step 4 - The walls are finished with a mud slurry allowing for organic design patterns and finally are white washed. The lines of individual courses are still visible after finishing (Figure 20). The walls of these houses are thicker at the bottom and thinner at the top. This is not done intentionally but since one course is laid over the other before fully drying, the lower courses of the wall spread out a bit under the weight of the upper courses. Thus the bottommost course is widest while the course at the top is thinnest. This phenomenon results in somewhat better stability of the walls.

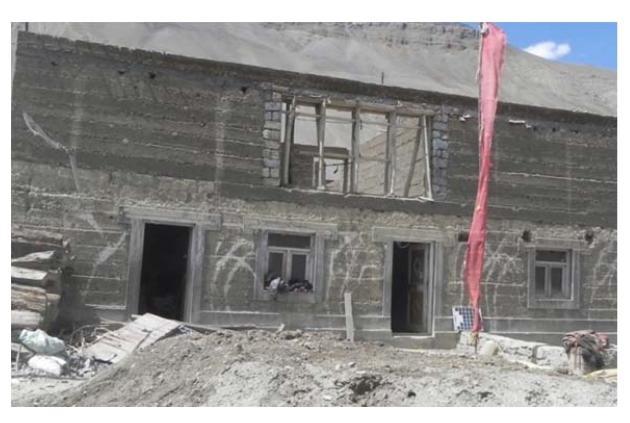
Figure 18. Marks can be seen on the wall of the upper floor where windows have to be cut. Lintel beams have already been provided during the wall construction process.

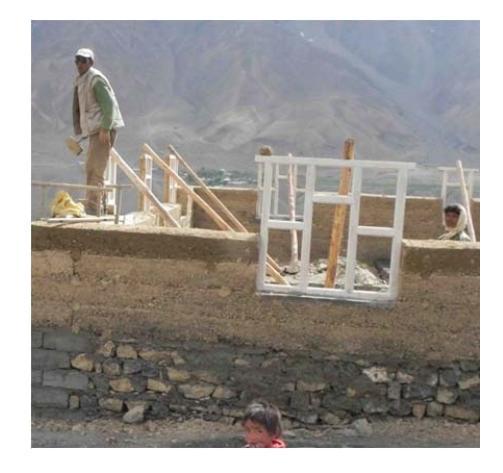
Figure 19. Walls with already placed window frames.

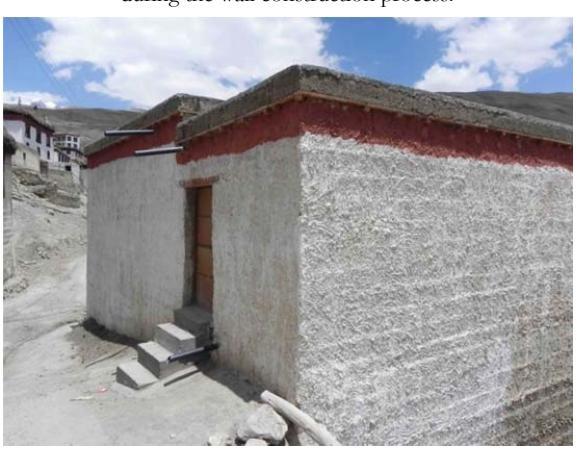
Figure 20. Patterns made to the outer walls with mud slurry for finishing.

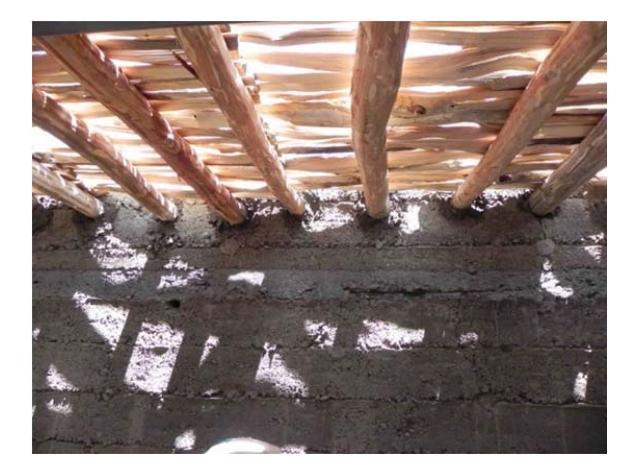
Figure 21. Branches are densely laid over poplar tree logs (beams).

<u>Floor system and roof typology</u>: Ground floor - The flooring at ground floor level consists of only an earth fill which is finished with mud slurry. Upper floors - Wooden beams are laid across the walls in one direction only. These are secured in place with mud only. The distance between the beams is kept small considering the strength and weight of the overlaying material. Tree branches and wooden planks are densely laid over them and then a 50 mm thick layer of mud is spread over it (**Figure 21**). Roof - As the area has very little or no rainfall, the roofs are flat and constructed in the same way as the floors. Nowadays, with somewhat improved connectivity for transportation, poplar tree logs or steel sections are sometimes used for the beams as well (**Figure 22**). Parapets - To construct the parapets, a 300 mm thick and 300 mm high course of mud is laid at the periphery of the terrace. On top of it, dried bushes are packed densely (**Figure 23**). These bushes are projecting to the outside and hence also act as a sunshade (**Figure 24**).

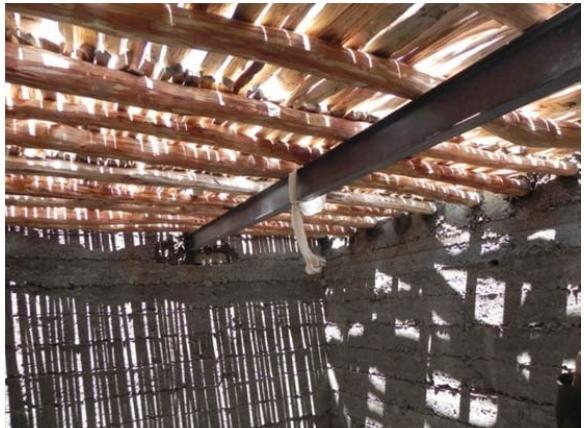
Figure 22. A steel I-section girder is used to support the beams.

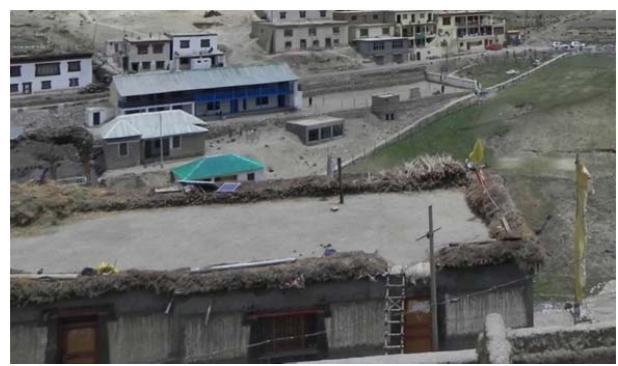
Figure 23. Parapet over a Spitian house terrace.

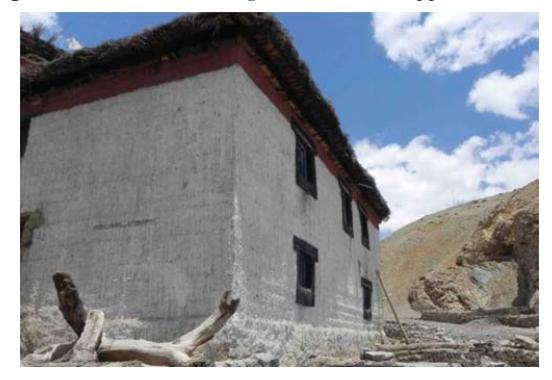
Figure 24. Bushes projecting outwards, hence forming a type of sunshade/roof projection.

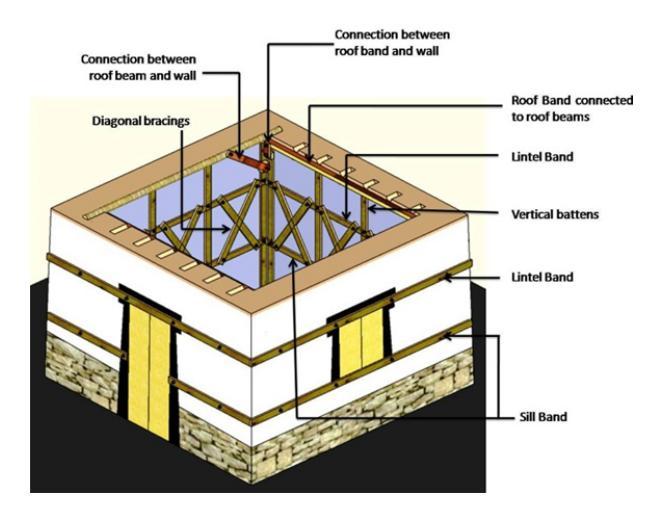
Figure 25. Retrofitting details for the walls.

Seismic Deficiency	Description of Seismic Strengthening provisions used
Low in-plane and out-of-plane strength of mud walls	The walls can be supported in-plane using a braced frame system. The posts of the braced frame will support the roof beams directly, so that even if the walls fail during an earthquake, collapse of the roof is avoided. The diagonal bracing in the frame provides the required in-plane strength to the walls. Wooden ties can be located at roof, lintel and sill levels on both sides of the walls to support them in out-of-plane action (Figure 25). The corners of walls and joints of girders with vertical posts can also be strengthened using diagonal bracings. This provides a resilient alternative system to resist vertical and lateral loads in the form of the wooden frame, duly braced in all directions.
Flexible roof/floor system	The main cause of damage to such roof and floor systems is the relative movement between the main girders. This relative movement can be restricted by providing horizontal bracing in the plane of the ceiling, interconnecting the girders (Figure 26).

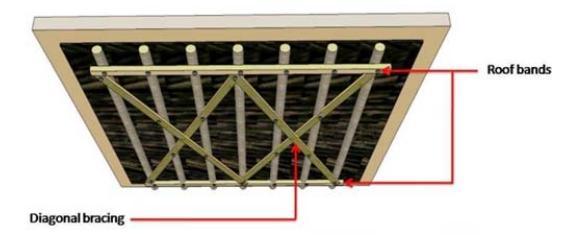
Figure 26. Retrofitting details for the roof.
