World Housing Encyclopedia

# HOUSING REPORT Single-family stone masonry house

Report #	28
Report Date	06-05-2002
Country	ΙΤΑLΥ
Housing Type	Stone Masonry House
Housing Sub-Type	Stone Masonry House : Rubble stone without/with mud/lime/cement mortar
Author(s)	Dina D'Ayala, Elena Speranza
Reviewer(s)	Miha Tomazevic

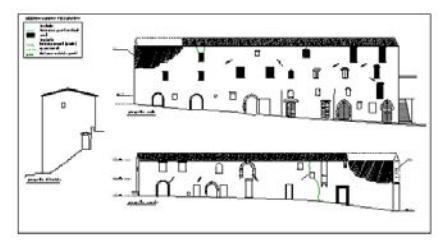
Figure 2: Key Load-Bearing Elements

The vertical load-resisting system is stone masonry walls. Single or double leaf masonry walls with rubble infill.

The lateral load-resisting system is stone masonry walls. Masonry walls with or without metal ties.

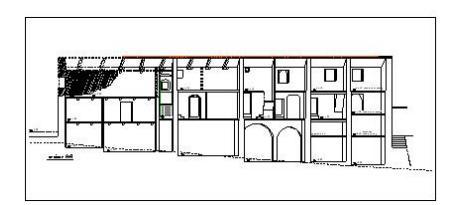
Figure 3A: An Elevation of a Typcial Building

Roughly rectangular as usually part of arrays or terraces, but alterations and joining of cadastral units may result in different shapes. Also front and back walls are not necessarily parallel as are not the party walls. Opening layout is frequently altered over time, so that it is very often irregular from one floor to the next one. Typical percentage are 30% to 50% of wall surface on facade, much less on side walls, but with exceptions. In regular cases for each floor of each

cell, there are two windows laid out in vertical arrays.

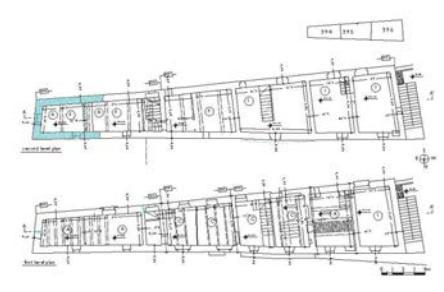
Figure 3B: Plan of a Typical Building

The typical plan dimensions of these buildings are: lengths between 4 and 4 meters, and widths between 6 and 6 meters. The building has 2 to 5 storey(s). The typical span of the roofing/flooring system is 5 meters. Typical Plan Dimension: The masonry œll dimensions are usually 4 X 6 m, but houses might result from aggregation of œlls. Typical Span: Usually typical span is from 4 to 6 meters Typical Story Height: Story height varies from 2.5 to 3.2 meters. The typical storey height in such buildings is 3 meters. The typical structural wall density is more than 20 %. Total wall area/plan area (for each floor) is from 0.17 to 0.25.

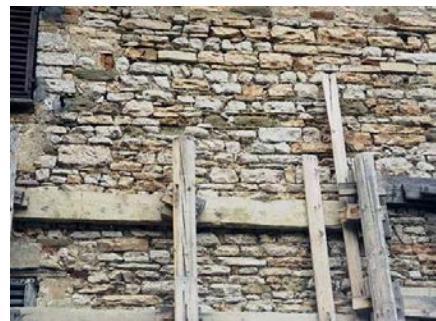
Figure 4A: Critical Structural Details Stone Masonry Wall With Irregular Roughly Dressed Stone Blocks of Varying Dimensions Embedded into Thick Lime Mortar Joints (not properly repointed)

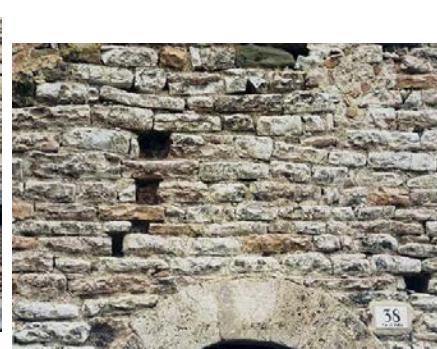
Figure 4B: Critical Structural Details-Movement the Blocks, Probably as a Result of Damage in Previous Earthquake and Visible Loose Stones Around the Arch

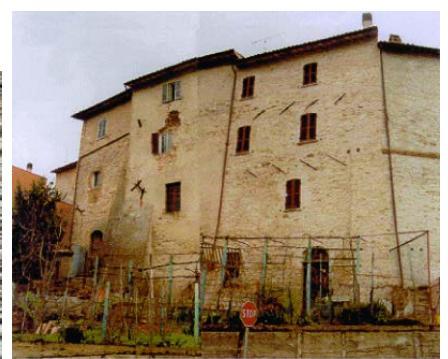
Figure 5A: Key Seismic Features and Deficiecies Showing the Regular Arrays of Floor Ties in One Unit, Irregular Distribution of Wall Ties in hte Next One, and Corner Return Return Stones in the Third Unit

Seismic features for a typical building of this type are illustrated in Figure 5A. Note the regular arrays of floor ties in one of the units, irregular distribution of wall ties in the next one, and corner return stones in the third unit. Due to the absence of adequate connections between internal and external leaves of masonry, a partial collapse of the area above the window opening took place.

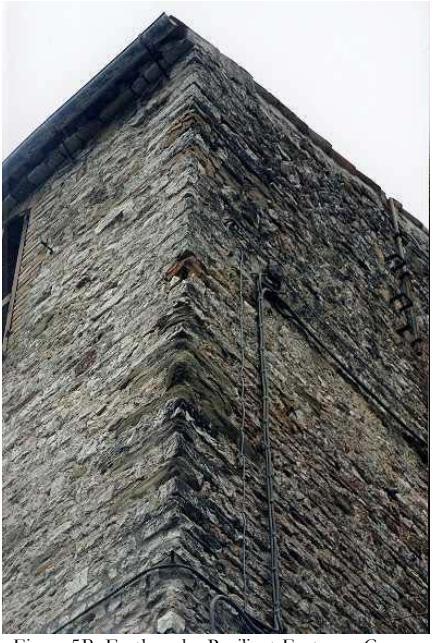
Figure 5B: Earthquake-Resilient Feature - Corner Returns between the Perpendicular Walls Made of Larger Stone Blocks

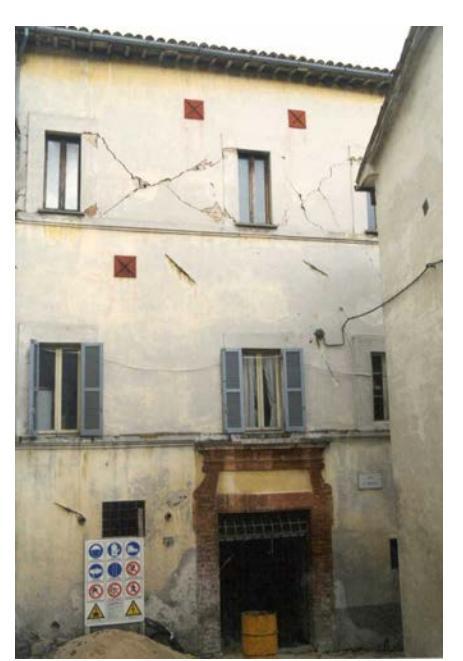
Figure 6A: Typical Earthquake Damage - "X" cracking of walls (1997 Umbria-Marche earthquake)

Structural Element	Seismic Deficiency	Earthquake Resilient Features	Earthquake Damage Patterns
Wall	-Level of bond in the geometric thickness of the multi-leaf walls Extent of connection between façade and party walls, depending on alteration and position of windows Level of bond between mortar and units depending on decay of original material and regular repointing.	-Corner returns betw een the perpendicular walls made of larger stone blocks are an original feature in many buildingsIn some buildings built in the last 100 years iron anchors connecting the floor timber structure to the wall are an as-built feature, see Figure 5A.	- In cases of poor bond between leaves, disintegration of the masonry fabric is the most common damage In cases of poor connection between facades and party walls, out-of- plane mechanism will take place resulting in partial or total collapse of one or more walls In cases of good connections between orthogonal walls, in-plane mechanism will take place resulting in diagonal cracking ("X" cracks), see Figure 6A.

Seismic Deficiency	Description of Seismic Strengthening provisions used
Lack of Structural Integrity	Installation of new RC ring beams with or without concrete slab. A procedure for the installation of a new RC ring beam in an existing stone masonry building is presented in Figure 7F. Note the dowels anchored into the existing walls and the new concrete slab atop the existing wood floor. Figure 7E shows an alternative solution, which includes the installation of steel anchors grouted into the existing walls and the installation of new concrete floor slab atop the existing wood floor. Figure 7A shows a building strengthened with new RC ring beams. It is very important to achieve the connection between the new RC ring beam and the existing masonry, otherwise the earthquake damage may be caused, as illustrated in Figure 6B.
Inadequate Wall-Floor Connection	Installation of new steel ties. Figure 7C shows a steel strap detail connecting an existing stone masonry wall to a timber floor joists. Figure 7D shows a detail of ties with an anchor plate at the exterior face of the wall. A building with the installed ties is shown on Figure 5A. It is very important to accomplish a regular distribution of ties - irregular tie distribution may be a cause of earthquake damage, as illustrated in Figure 6A.

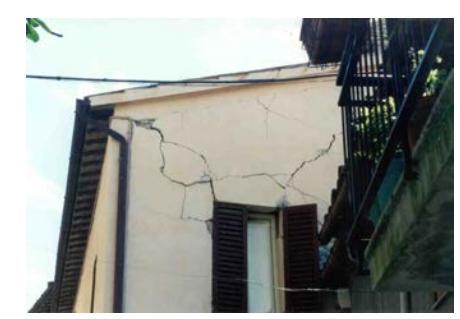
Figure 6B: Earthquake Damage to a Retrofitted Building to the Inadequate RC Ring Beam-Wall Connection

A small proportion of these buildings collapsed in the town centers and usually these had very poor maintenance record, i.e. the buildings had not been occupied for a number of years. A greater proportion of similar buildings (still within 25% of the total number) collapsed in the smaller mountain villages doser to the epicenter. Two main factors can be considered as possible causes of this disparity, assuming a similar level of seismic excitation: worse construction quality, and the fact that the houses in the villages are isolated, whereas in the towns they are built in the rows. Figure 6A shows a house in the historic centre of Nocera Umbra, subjected to the 1997 Umbria-Marche earthquake. Typical "X" cracks developed in masonry walls, in this case caused by the increased stiffness of roof structure that had been replaced by reinforced concrete slab with ring-beam. Figure 6B illustrates the earthquake damage associated with the

inadequate ring beam-wall connection. The roof had slipped on the masonry and caused the wall damage.

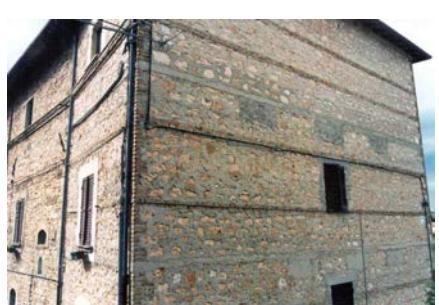
Figure 7A: Illustration of Seismic Strengthening Techniques

Figure 7A illustrates the following seismic strengthening provisions: RC ring beams and anchorage of floor beams to the wall, repointing and grouting using œment-based grout, corner return in brickwork, and the installation of concrete window frame. Figure 7B illustrates modern anchors with anchorage plates and concrete lintels over openings.

Low Lateral- Load Resistance of the Walls	Grouting, see Figure 7A.

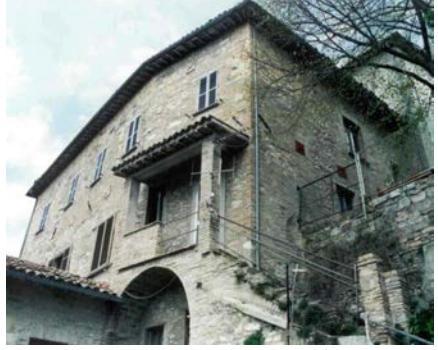
Figure 7B: Seismic Strenghthening Techniques-Installation of modern anchors with anchorage plates and concrete lintels over openings

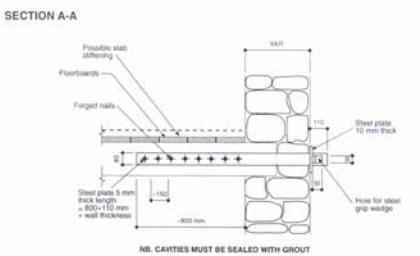
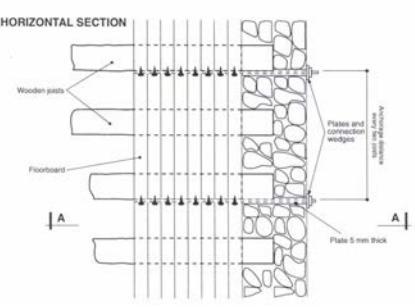
Figure 7C: Seismic Strengthening - Steel Strap Used to Connect an Existing Masonry Wall to Timber Floor Joists

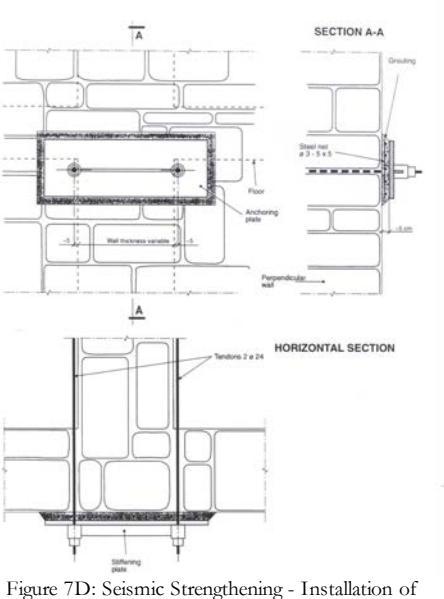
Ties with an Anchor Plate at the Exterior Wall

Face

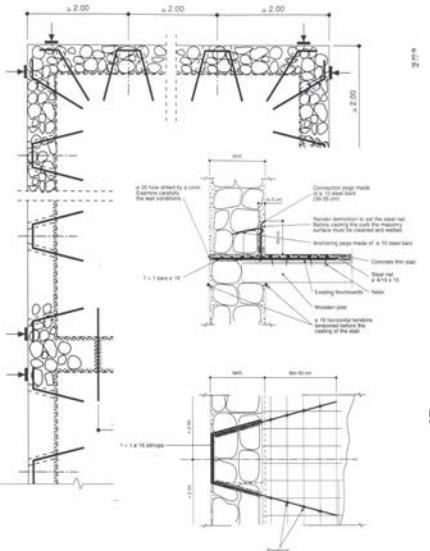
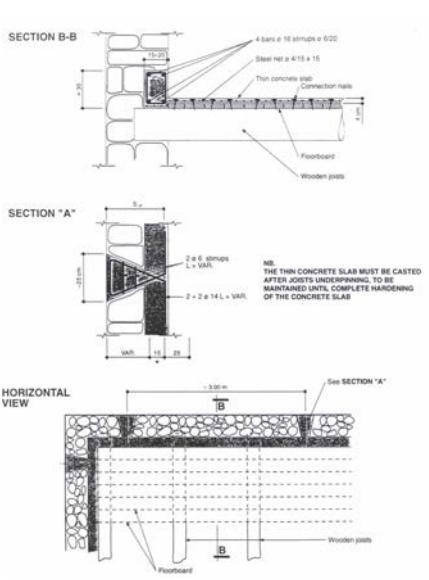
Figure 7F: Seismic Strengthening - Installation of New RC Ring Beam
