GEM Building Taxonomy Report

Oamaru Limestone Building

Jitendra Bothara

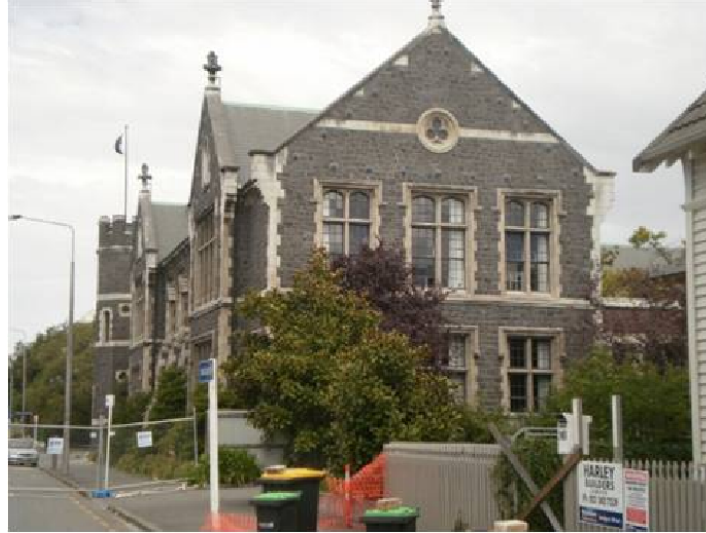
New Zealand, Peterborough (1920s), corner of Peterborough and Montreal Streets, Christchurch. Exteriors stone work is Halswell Basalt with Oamaru Limestone facings
