GEM Building Taxonomy Report

Stone House in Gilgit NED University

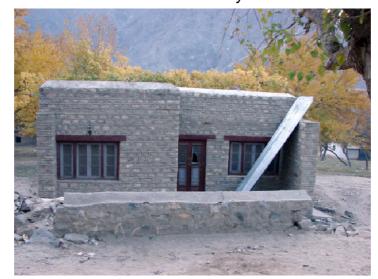
DX /MUR+STDRE+MOC /LWAL /DY /MUR+STDRE+MOC /LWAL / /HEX:1+HBEX:0 /RES+RES1 /BP1 /PLFL /IRIR+IRPP:REC /EWMA /RSH1+RMN+RO /FN /

Material type (direction 1): Masonry, unreinforced Material properties (direction 1): Cement mortar Lateral load-resisting system (direction 1): Wall Material type (direction 2): Masonry, unreinforced Material properties (direction 2): Cement mortar Lateral load-resisting system (direction 2): Wall Foundations: Unknown foundation system Type of Irregularity: Irregular structure Plan structural irregularity - primary: Re-entrant corner Plan structural irregularity - secondary: No irregularity Roof shape: Flat Roof system material: Roof material, other Roof connections: Roof-wall diaphragm connection unknown Floor system material: No elevated or suspended floor material (single-store) Floor connections: Floor-wall diaphragm connection, unknown Exterior walls material: Masonry Date of constrution: Year unknown Number of storeys above the ground: Exact number of storeys 1 Height of the grade above ground floor: Height above grade unknown Occupancy type - general: Residential Country: Pakistan Summary:

Material technology (direction 1): Dressed stone Material technology (additional, direction 1):

Plan shape: L-shape Building position within a block: One adjacent building
