## **GEM Building Taxonomy Report**

**Traditional House NED University**

Town of Karimabad, Hunza Valley, Gilgit Baltistan province

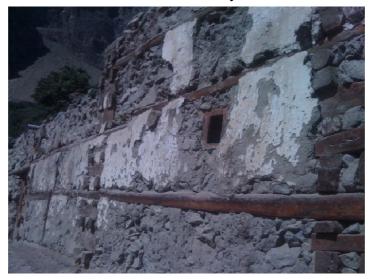
Masonry, reinforced

Rubble (field stone) or semi-dressed stone

Wood-reinforced

Wooden roof structure supporting a heavy flat or domed roof

Traditional style of construction in the region
