# GEM Building Taxonomy Report

## Traditional Building Style

NED University

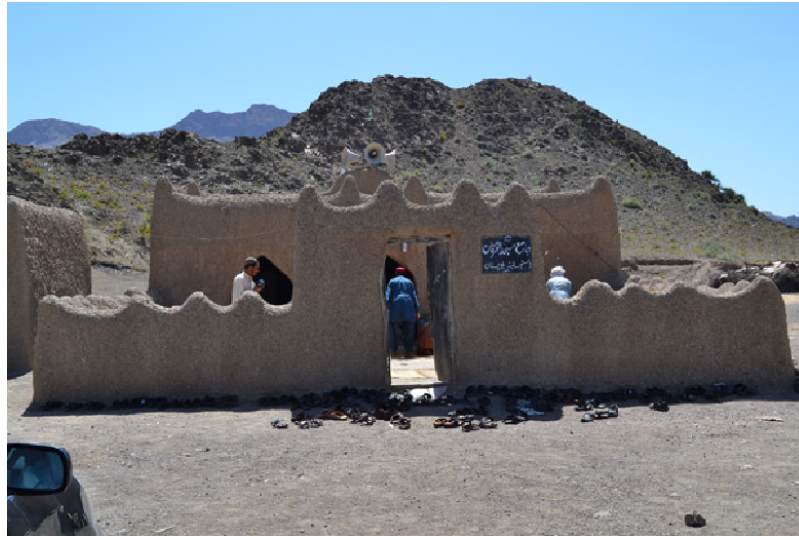
Masonry, unreinforced

Mud mortar

Roof-wall diaphragm connection not provided

Adobe blocks

Earthen

Wooden roof structure supporting a heavy flat or domed roof

A traditionally constructed mosque on the side of the road.
