GEM Building Taxonomy Report

Adobe house in Nazca (Peru)

Nicola Tarque

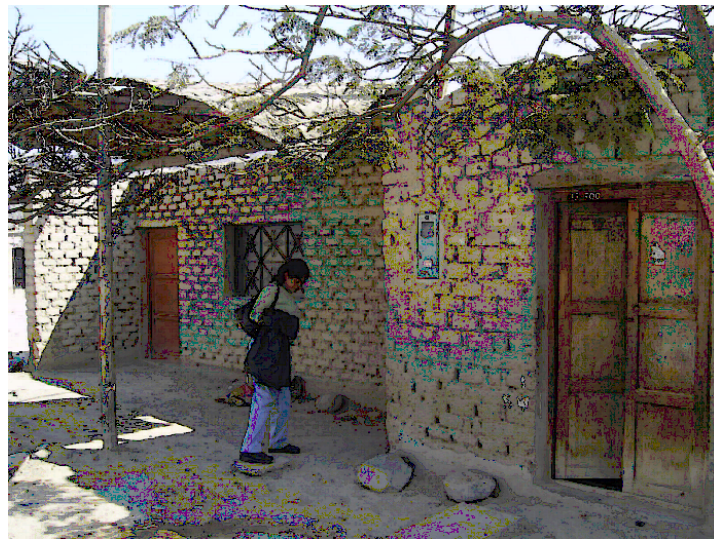
This is a typical adobe building at the Peruvian coast. The roof is made of straw mat, cane, and mud; sometimes some metal sheets. The lintels are made of reinforced concrete.
