GEM Building Taxonomy Report

GR_Lona_23 Mercedes Feriche

Typical old residential buliding

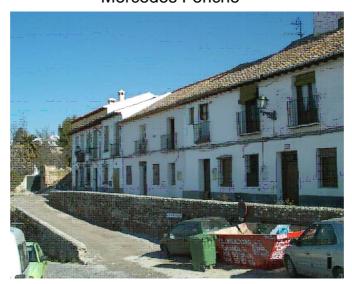
Material type (direction 1): Masonry, unreinforced Material properties (direction 1): Lime mortar Lateral load-resisting system (direction 1): Wall Material type (direction 2): Masonry, unreinforced

Roof shape: Pitched with gable ends Roof system material: Wood Roof connections: Roof-wall diaphragm connection not provided Floor system material: Wood Floor connections: Floor-wall diaphragm connection not provided Exterior walls material: Masonry Date of constrution: Approximate date of construction or retrofit 1900 Number of storeys above the ground: 2 Exact number of storeys Height of the grade above ground floor: Height above grade unknown Occupancy type - general: Residential Country: Spain Summary:
