GEM Building Taxonomy Report

Grass/Thatch House 02

NED University

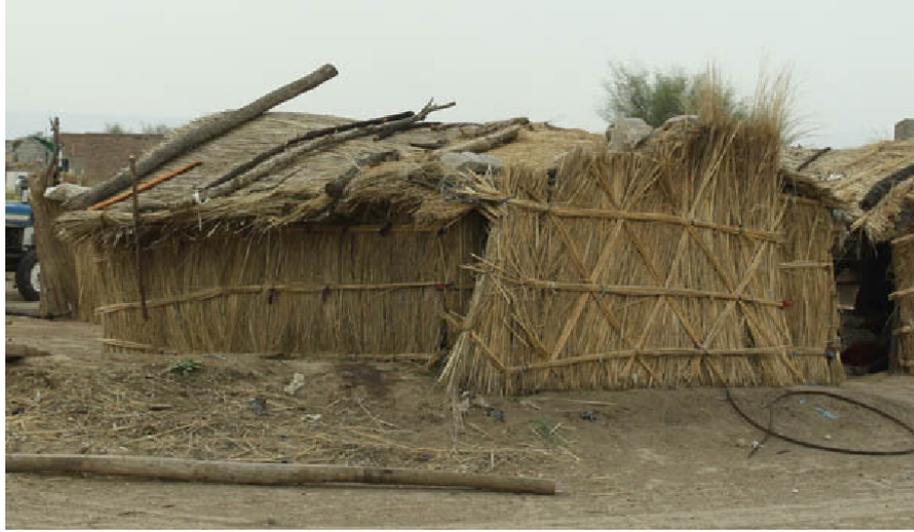
A makeshift abode for a nomad family along the Highway, Sindh, locally also known as Manna house
